Manhole Inspection Summary

Manhole # S31GG2009MH

Insp Date: **11/29/06 11:05 AM**

Location Address: **20 MEADOWOOD RD**

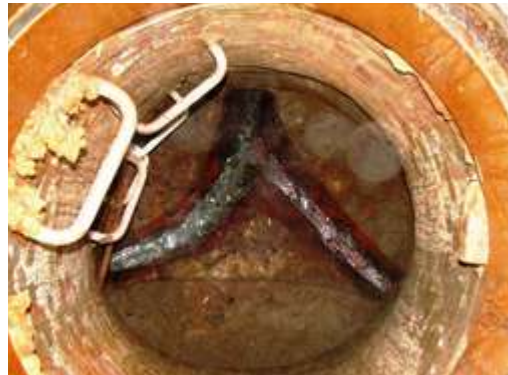
Top View

Evidence of surcharge - Bench debris.

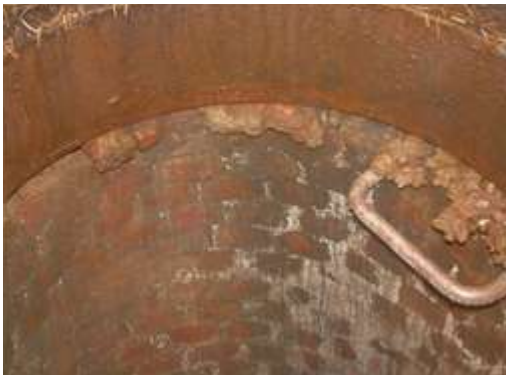
Defect

Frame leaks. Adjustment deterioration, loose brick and infiltration - other side.

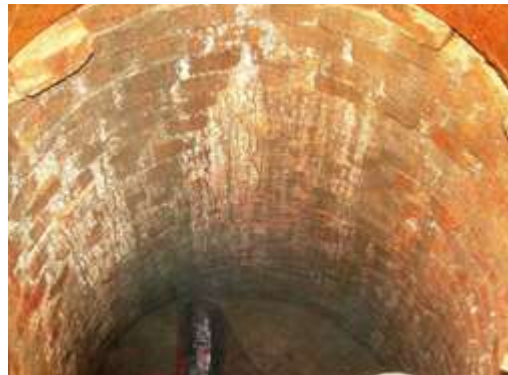
Defect

Adjustment deterioration and infiltration. Barrel infiltration.

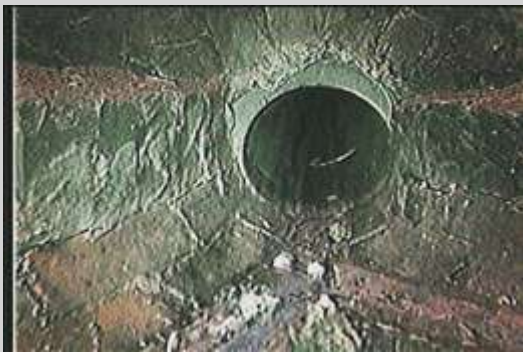
8 in. Circular Gravity Sewer Pipe Out @ 12 O'Clock

Infiltration: **Evidence** Pipe Seal Cond: **Roots**

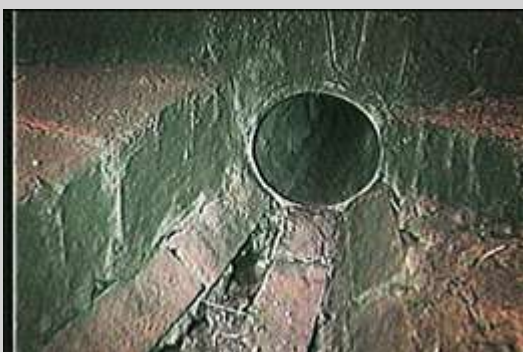
6 in. Circular Gravity Sewer Pipe In @ 4 O'Clock

Channel deterioration and root intrusion.

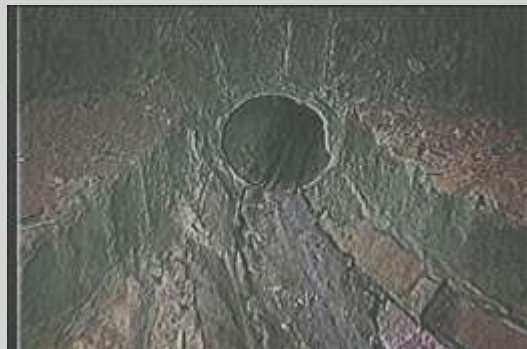
Pipe In @ 8 O'Clock

Barrel deterioration and infiltration. Channel deterioration.
